The Elms, Seattle WA

ACE DuraFlo – The Repiping Alternative

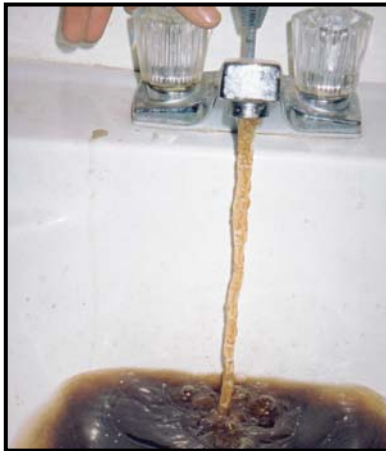
The Elms - a senior oriented apartment project built in the 1960's. The piping system was comprised of galvanized steel pipe that had rusted, resulting in low flow, brown water and pinhole leaks. The main line ran under the main floor slab and then serviced the suites from the ground floor up to the top floor.

After completing conventional repairs to the piping system the main and branch lines of this 64 unit building was isolated and the piping system was restored.
