Seattle King County Courthouse

Corrosion Control 4" Main Waterline

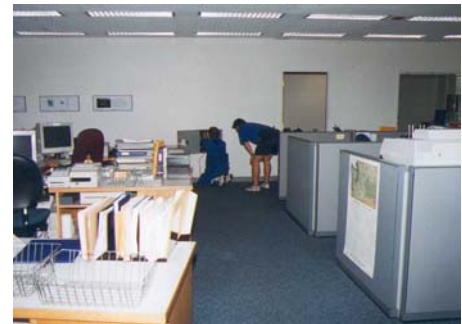
To protect and extend the life of the 4" main water line in the Seattle Courthouse and main Administration building. The present piping system was encrusted and wrapped in asbestos. Repair or replacement had to be completed during 1 weekend as shut down of the facility was not feasible.

The 4" main water line ran horizontally, encased in concrete, under the main level of this 10 floor mid-rise building then ran up to the ceiling in the 10th floor. Access to the main line was available at the lower level and an exit was available at the top, 10 floors up. The length of pipe was estimated to be 100 feet horizontally and 120 feet vertical. Pipe diameter was consistent at 4".

The repiping option was considered, but due to the down time and costs associated with asbestos abatement, coring and basic pipe replacement was judged to be cost and time prohibitive.
