The Elms, Seattle WA

ACE DuraFlo – The Repiping Alternative

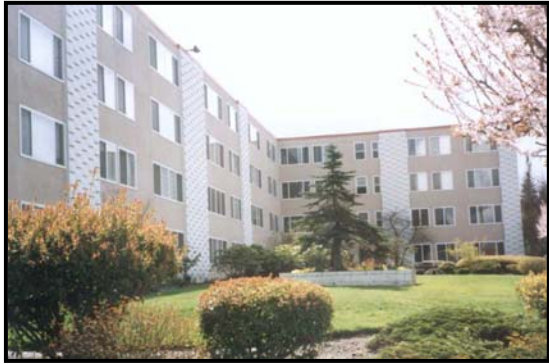
Brown Water - Low Flow – Pinhole Leaks

The Elms - a senior oriented apartment project built in the 1960's. The piping system was comprised of galvanized steel pipe that had rusted, resulting in low flow, brown water and pinhole leaks. The main line ran under the main floor slab and then serviced the suites from the ground floor up to the top floor.

After completing conventional repairs to the piping system the main and branch lines of this 64 unit building was isolated and the piping system was restored.

Pipes restored by ACE DuraFlo ranged in size from the 3" main line to city service down to 1/2" branch lines at the angle stops in each suite.
