Desert Regional Medical Center Palm Springs, CA

ACE DuraFlo – The Repiping Alternative

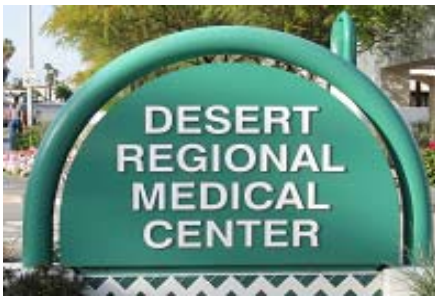
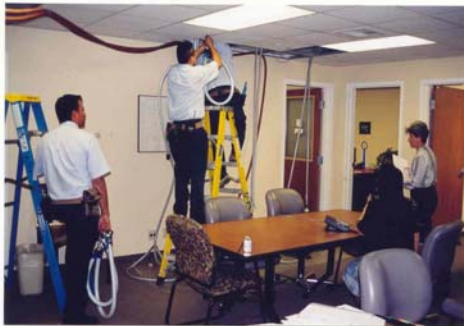
The problem they were experiencing was related to pipe corrosion in the piping system in the facilities chilled water and heating system. The two pipe heating- cooling system was made of Schedule 40 black steel main lines with soft copper branch lines. Pipe diameters ranged from 1/2" to 2 1/2". In addition to the main line being encrusted the soft copper branch lines had developed pinhole leaks. Strainers at the heating units had been installed previously to try and strain out the rust particles from the main line but now they were constantly getting plugged up by the debris. Given the need to have little or no patient or operational disruption, the traditional re-pipe option was ruled out by the facilities engineers.

ACE DuraFlo® in-place pipe restoration. The piping system was isolated and conventional repairs carried out and then the piping system was restored in-place using the ACE DuraFlo® system of in-place pipe restoration. By restoring the piping system in-place the facility was able to remain in full operation.
